TURBINE BLADE INSPECTION METHODS

António Pinho

8.2 Especialistas em Energias Renováveis, Lda.
Avenida João Gualberto 1881, 80030-001 Curitiba
antonio.pinho@8p2.com.br

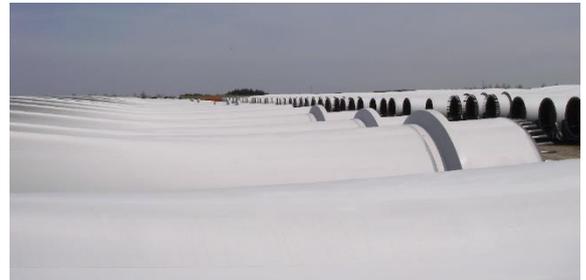
Before the 2 blade shells are bonded together –

The inspectors have the opportunity to check if the internal structure is correctly installed and bonded. Furthermore inspectors have the opportunity to check if the lightning protection system is well installed (ex: check if the conduct wire is properly connected to the receptors).

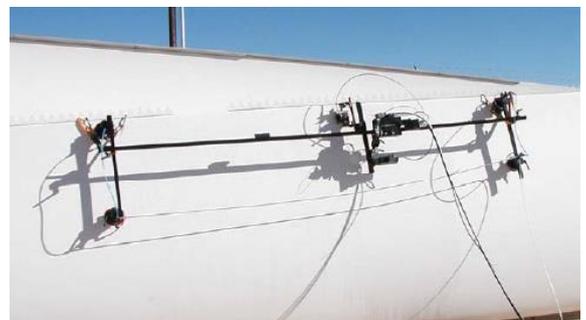
Ultrasonic scanner – Detection of defects inside the composite blade material, like fiber wrinkles, missing adhesive, dry areas, delamination and porosity.

Thermography – Opportunity to use of thermography technics like:

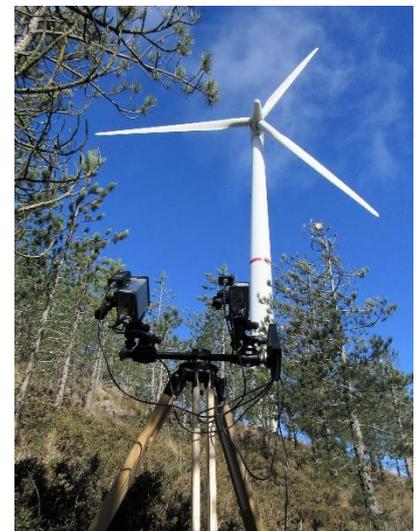
Aerodynamic imbalances caused by blade angle deviation can be detected with a reflectorless laser distance measurement, like the one used in the 8.2 group.

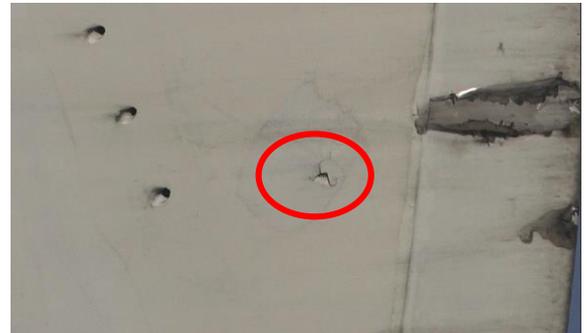
The advantage of drone inspection is the possibility to make a close optical inspection to the blade, so smaller defects can be detected. Furthermore, a thermal inspection of blades can also be done and detect hidden defects like hollow areas or irregular bonding of the surfaces. Drone inspection is a relative low cost inspection method and the turbine stopping time is relatively short at around 30 min.

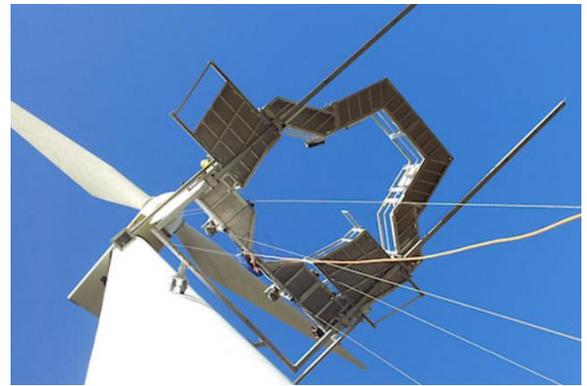
Blade inspections with platform allows a full inspection of the blade.

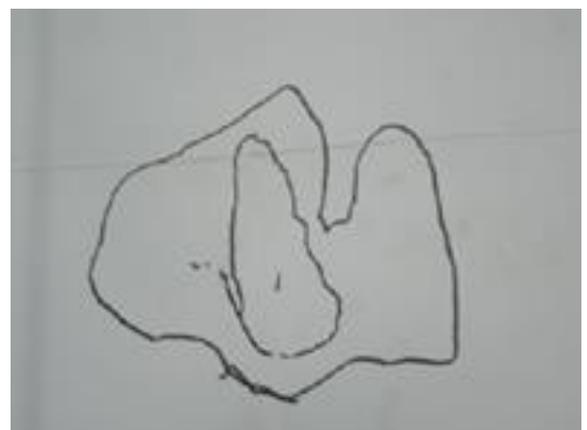
- The "Tap test" is very important to perform a correct evaluation of damage extension and magnitude and to prevent "hidden" damages.
- Active thermography inspections, with the use of infrared lamps, allow detecting extension and depth of hidden damages;
- The lightning protection system (LPS) is evaluated by conductivity measurement;
- Drainage system is assessed.

Very often lightning receptors in blades are not working. Defective LPS combined with clogging in drain system can lead to serious structural

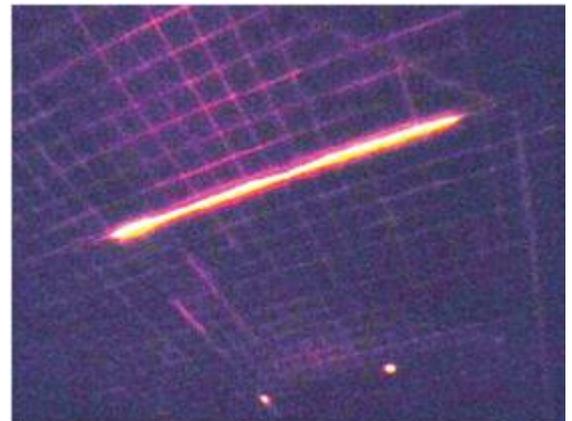
The inside blade inspection allows the detection of structural defects, core defects, delamination, cracks, cavities and surface imperfection at an early stage.

8.2 expertise provides excellence on technical results. A complete inspection to the inside blade can be performed, with visual examination at close distance with support of solar light, UV lamp, thermography, tapping and remote camera or videondoscopy (to inspect the inaccessible parts of the blade). Furthermore, the condition of the pitch system can be assessed by inspecting the pitch teeth and analyzing their bearing grease.
